PHASE I ENVIRONMENTAL SITE ASSESSMENT

JULY 2012

ANTIOCH ANNEX AREA 2B Antioch, California

For: CirclePoint Oakland, California

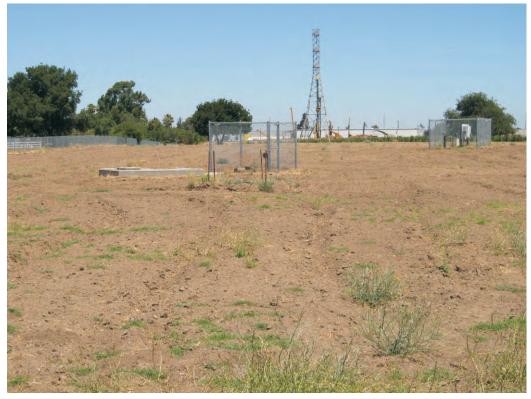
PHOTOGRAPHS FROM SITE RECONNAISSANCE, Figure 3A 4 July 2012

Photograph 1: Former Almond Orchard Property Looking North.

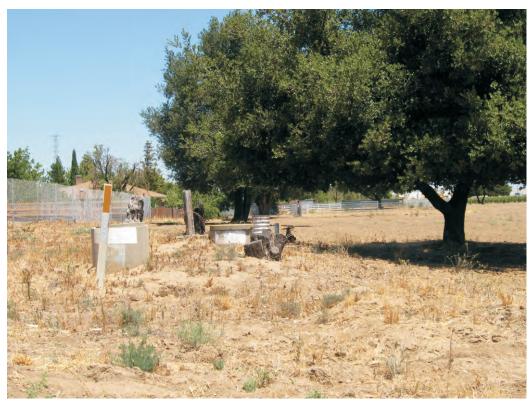
Evidence of subsurface vaults was observed on the Silva's storage area (Figure 3C, Photograph 5), the Southern Almond Orchard (Figure 3A, Photographs 1 and 2), and the property at the southeast corner of Viera Avenue and the railroad tracks (Figure 3E, Photograph 9). The purpose of the vaults is not known.

Photograph 2: Buried Vaults, West Boundary of Former Almond Orchard, Looking North.

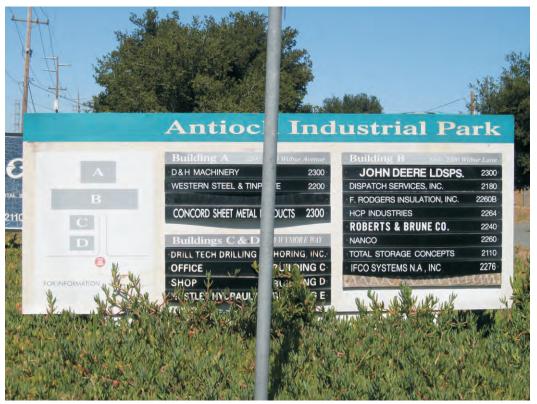
PHOTOGRAPHS FROM SITE RECONNAISSANCE, Figure 3B 4 July 2012

Property 4 is located north of the Site and west of Wymore Way. According to a sign at the northwest intersection of Wymore Way and East 18th Street (Figure 3B, Photograph 3), Buildings C and D of the Antioch Industrial Park both have the address of 2200 Wymore Way. This facility was listed by EDR as a hazardous waste generator with a hazardous materials management plan and an aboveground storage tank. The facility has had an inactive status since

A portion of the Antioch Industrial Park formed the northern Site boundary in the Wymore Way area. A sign at the intersection of Wymore Way and East 18th Street listed the occupants of the Antioch Industrial Park (Figure 3B, Photograph 3). The occupants listed for the two buildings closest to the Site, Buildings C and D located west of Wymore Way, were Drill Tech Drilling and Shoring, Inc.; an office; a shop; and Hustler Hydraulics. Stored machinery and parts were observed in this location (Figure 3G, Photograph 13).

Photograph 3: Sign for Antioch Industrial Park at Wymore Way.

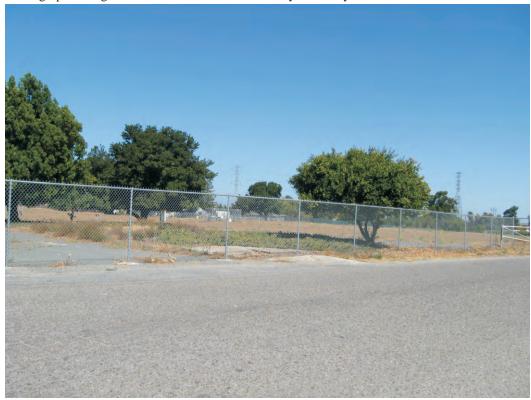
Photograph 4: Former Parking Area and Almond Orchard at Wymore Way.

- Silva's Memorials and storage yard at the northeast corner of East 18th Street and Wymore Way. Silva's Memorials, a gravestone supply business, was a small, one-story building with some stone storage adjacent to the building. Silva's storage yard, a long, fenced area along the east side of Wymore Way, was vacant at the time of the Site reconnaissance (Figure 3C, Photograph 5). Historical aerial photographs and the current Google Maps aerial photograph show this storage area was in use from at least 1993 until very recently. An overgrown, paved parking area present west of Wymore Way may have been in use in the past by Silva's Memorials (Figure 3B, Photograph 4).

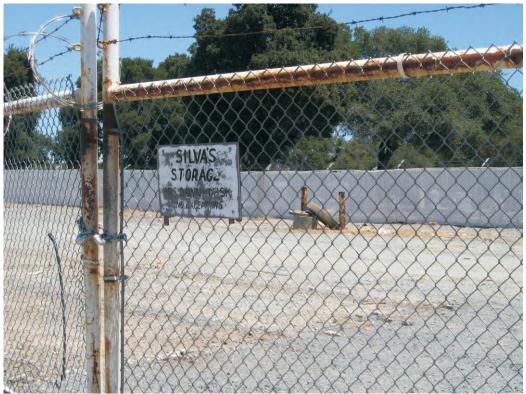
PHOTOGRAPHS FROM SITE RECONNAISSANCE, Figure 3C 4 July 2012

Photograph 5: Underground Vault on Silva's Memorials Storage Yard on Wymore way.

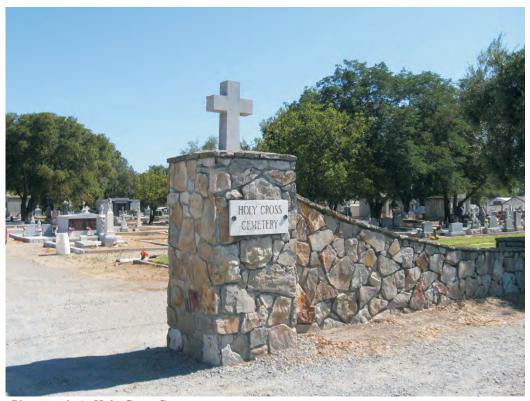
- Hazardous materials may be present in the cemetery in the form of embalming chemicals potentially used to preserve the human remains. In addition, the concentration of human remains, which are composed of naturally-occurring organic and inorganic compounds, in a relatively small area may represent a potential source of groundwater contamination.

Photograph 6: Holy Cross Cemetery.

Based on the findings of the Phase I ESA, BASELINE recommends additional investigation of soil at the Site if utility construction is planned adjacent to the cemetery or below power lines or towers on the Site. Soil samples should be collected and analyzed for formaldehyde and arsenic near the cemetery, and for PCBs below the power lines to evaluate if these Contaminants of Concern present a risk to human health.

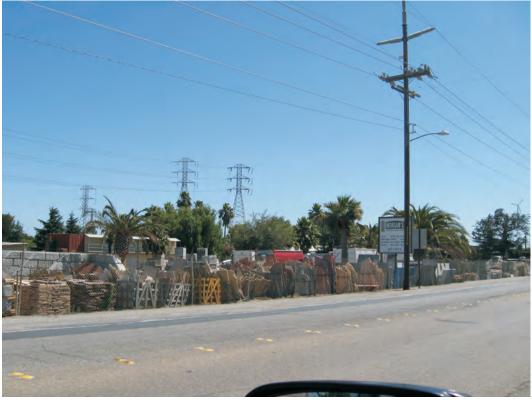
Photograph 7: Morgan's Home and Garden Center Looking Northeast.

- Bridgehead Café at 2415 East 18th Street. Bridgehead Café was a small café with an asphalt parking lot.
- Morgan's Home and Garden Center at 2555 Viera Avenue. Morgan's Home and Garden Center was a landscape supply company with multiple large bins of soil and gravel. Small front-loaders and several large trucks were present on the property (Figure 3D, Photographs 7 and 8).

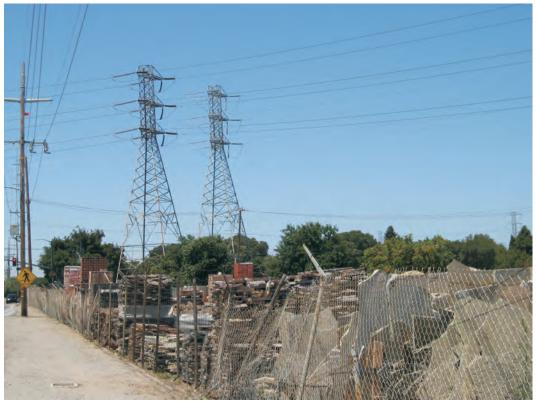
PHOTOGRAPHS FROM SITE RECONNAISSANCE, Figure 3D 4 July 2012

Photograph 8: Overhead Power Lines near Viera Ave and E. 18th St, Looking Northwest.

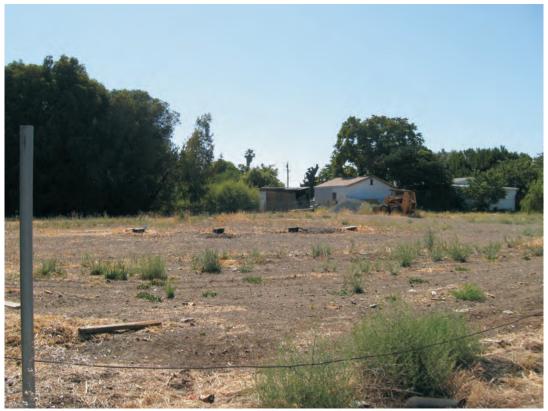
PHOTOGRAPHS FROM SITE RECONNAISSANCE, Figure 3E 4 July 2012

Photograph 9: Pipes Buried in Ground at SE corner of Viera and Railroad Tracks.

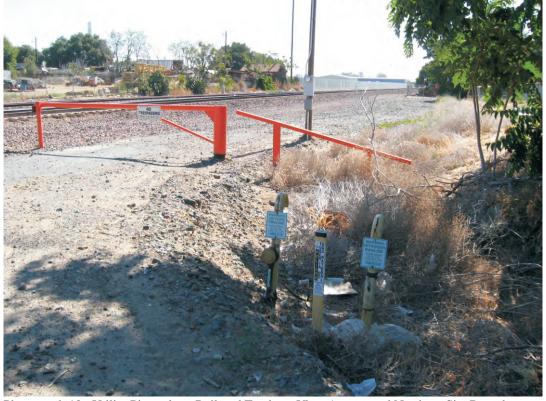
Photograph 10: Utility Pipes along Railroad Tracks at Viera Avenue and Northern Site Boundary.

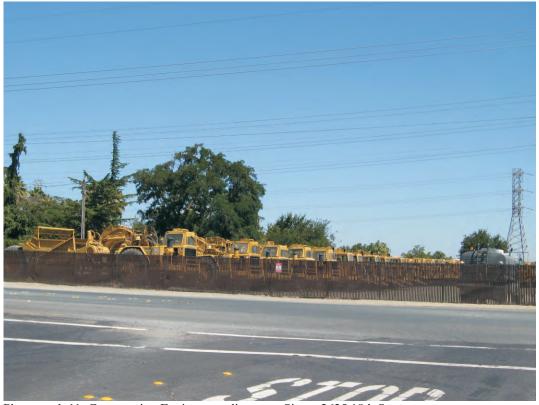
PHOTOGRAPHS FROM SITE RECONNAISSANCE, Figure 3F 4 July 2012

No evidence of hazardous materials release was observed at the adjoining properties. However, many of these properties store and maintain vehicles and machinery, indicating the use of petroleum products and the possible use of solvents. Based on the absence of vegetation near the railroad tracks adjacent to the northern Site boundary, herbicides may be used in this area.

Photograph 11: Construction Equipment adjacent to Site at 2625 18th St.

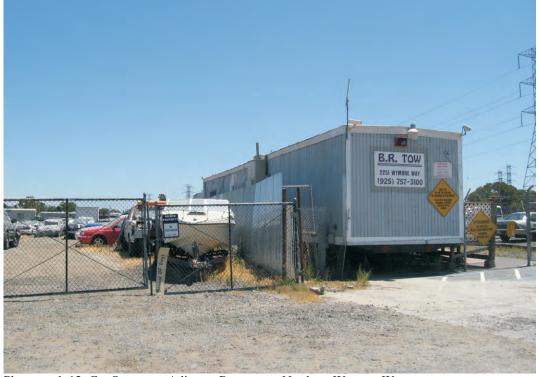
Photograph 12: Car Storage at Adjacent Property to North on Wymore Way.

B.R. Tow, a car towing company, was located at the northern property boundary east of Wymore Way. Cars in disrepair and car parts were stored on this property. (Figure 3F, Photograph 12).

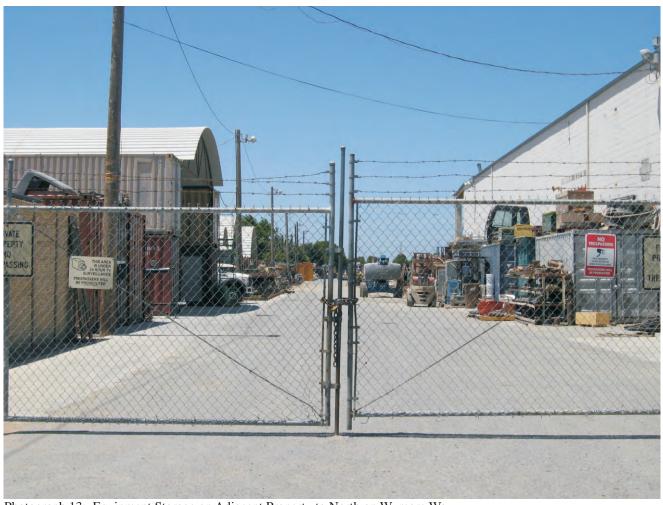
PHOTOGRAPHS FROM SITE RECONNAISSANCE, Figure 3G 4 July 2012

Photograph 13: Equipment Storage on Adjacent Property to North on Wymore Way.
