Cultural Resources Report

**Cultural Resources Technical Report
for the 5200 Lone Tree Way
United Pacific Gas Station Project**

August 27, 2021

Stantec Consulting Services Inc.

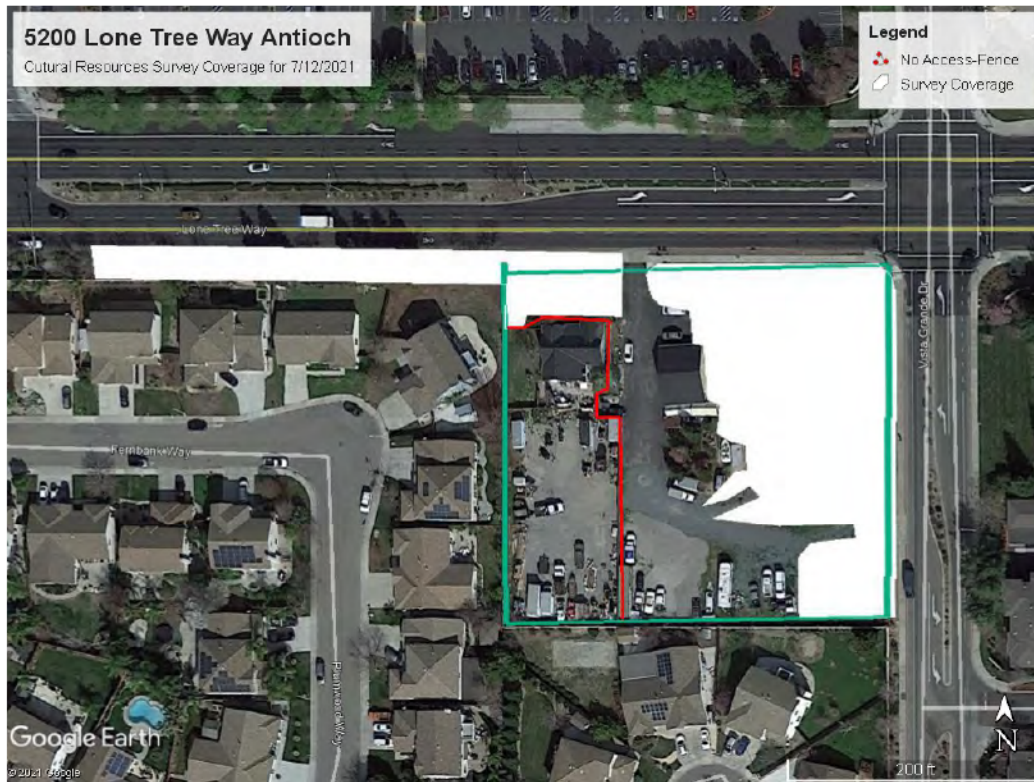
Map 1: Survey Coverage for 5200 Lone Tree Way Antioch, completed 7/12/2021

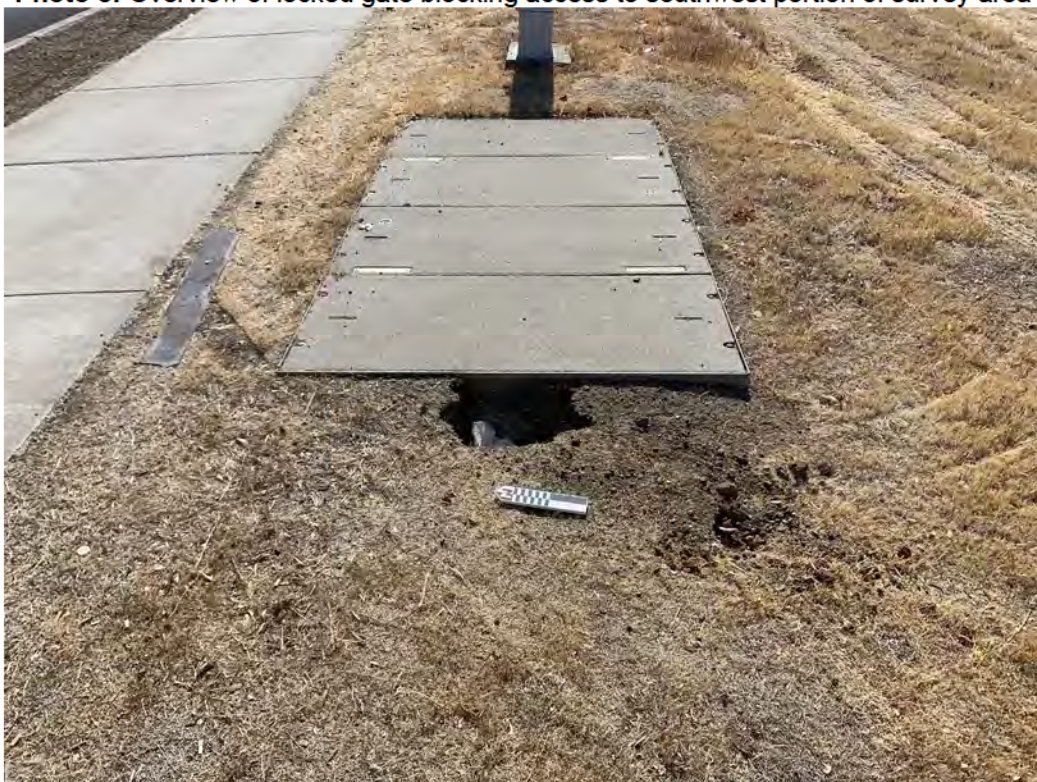
Photo 6: Overview of utilities vault (disturbance), facing east

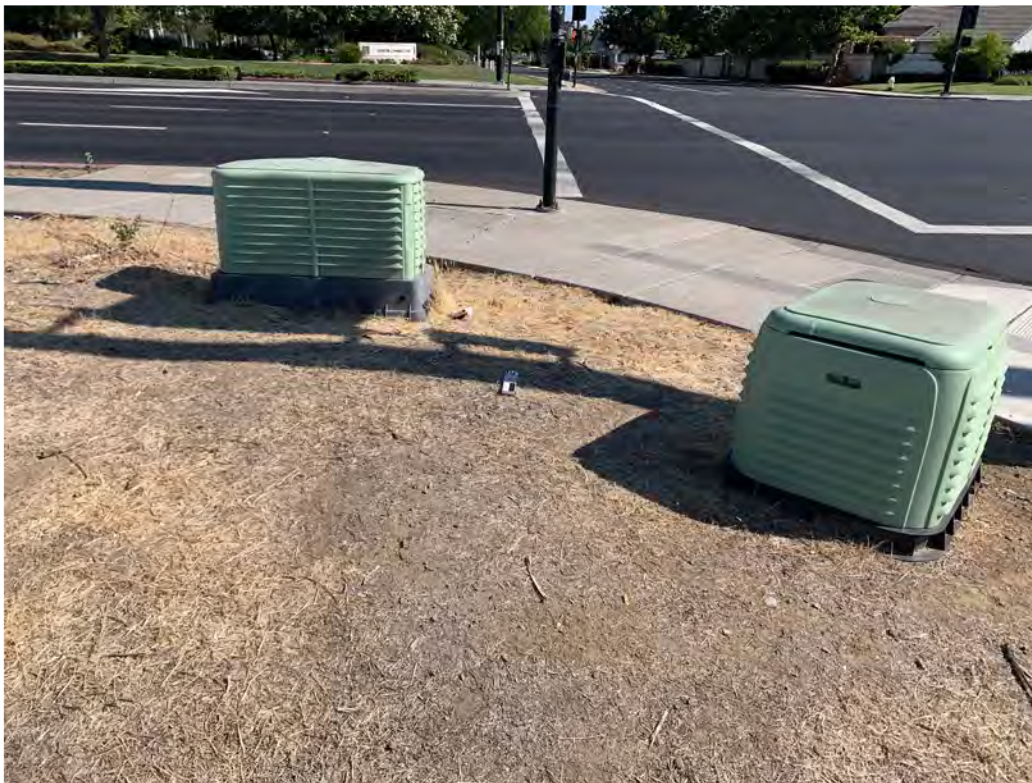
Photo 7: Overview of telecommunications boxes (disturbance), facing north

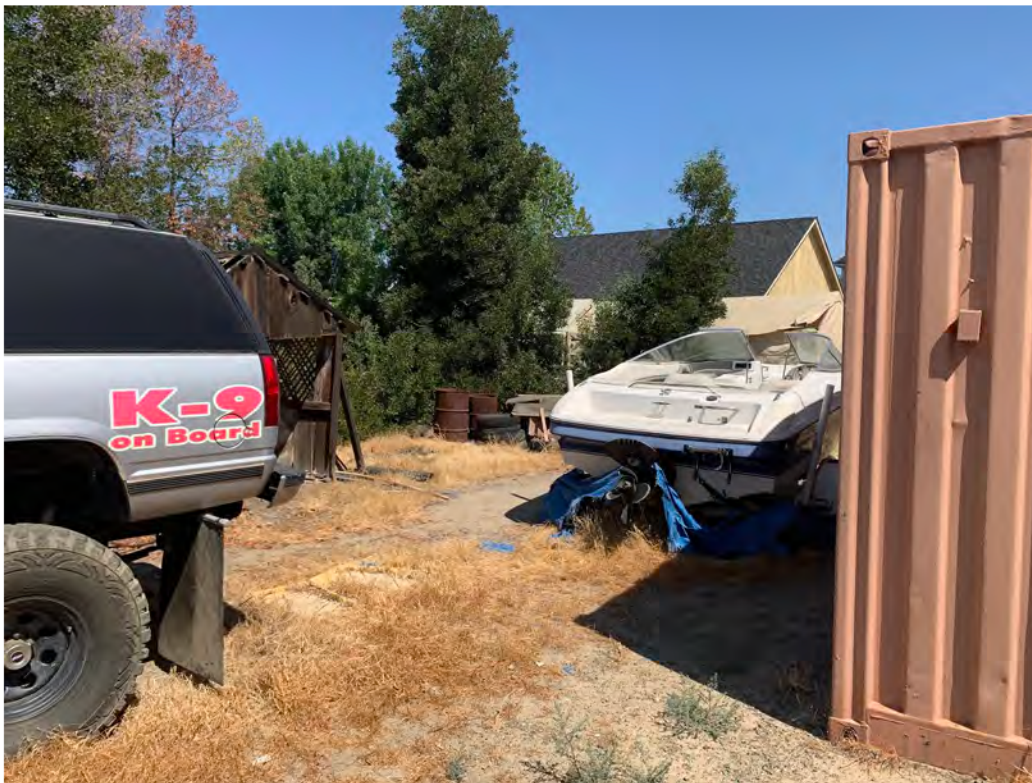
Photo 9: Overview of modern refuse dump location (disturbance), facing northwest

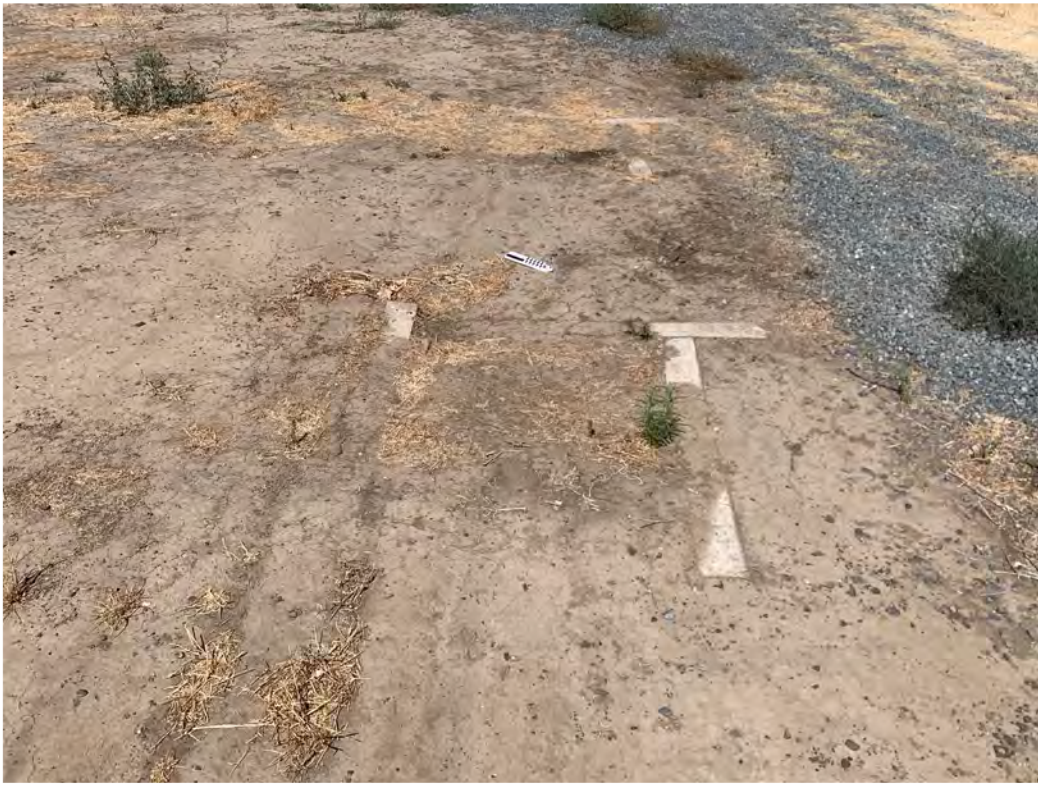
Possible footings/foundations were found approximately 50 feet south of barn; no diagnostic artifacts were observed within or near the foundation, so just a photo and general location were recorded.

Photo 15: Possible structure footing/foundation remnants, facing west/southwest

Recommendations: Due to the historic component of the property, the minimal surface soils observed, monitoring would be recommended during ground disturbing activities to provide an opportunity to see what is below the asphalt and imported gravel.

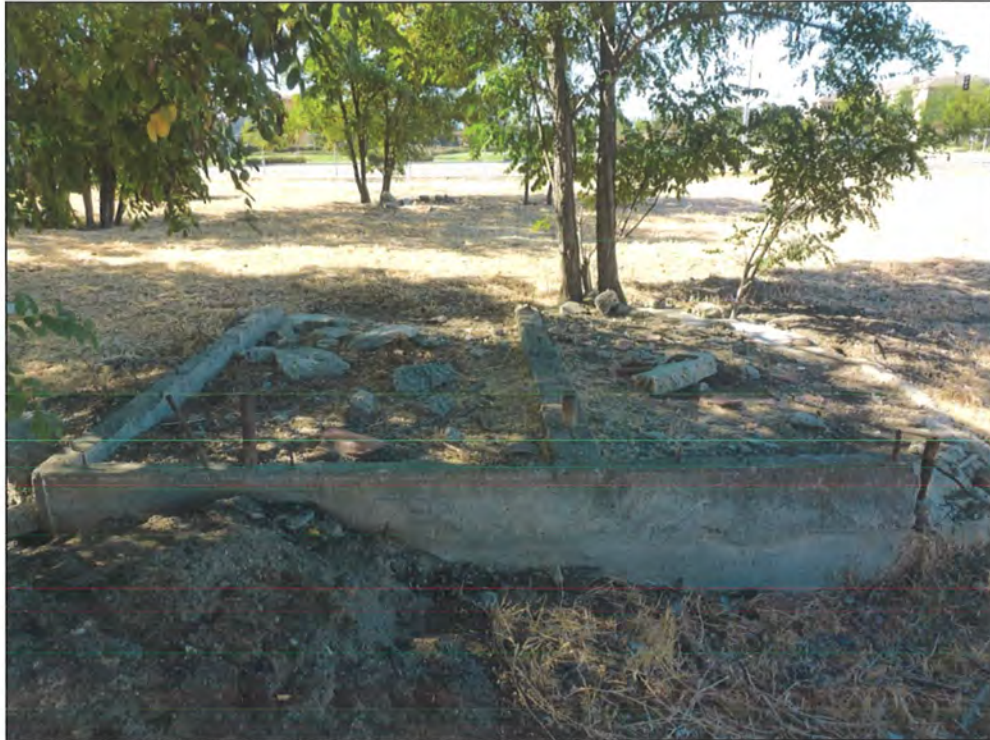
A few mounds of broken concrete were found piled on top of the bathroom foundation, but it was not clear if the piles were from recent nearby construction or from the school house. No historic artifacts were observed within the site boundaries. Overall, the site appeared to be in poor condition with further destruction caused by disturbance from surrounding construction.

Possible bathroom foundation with raised concrete pad in background, view south, 8/23/2013, Photo #006

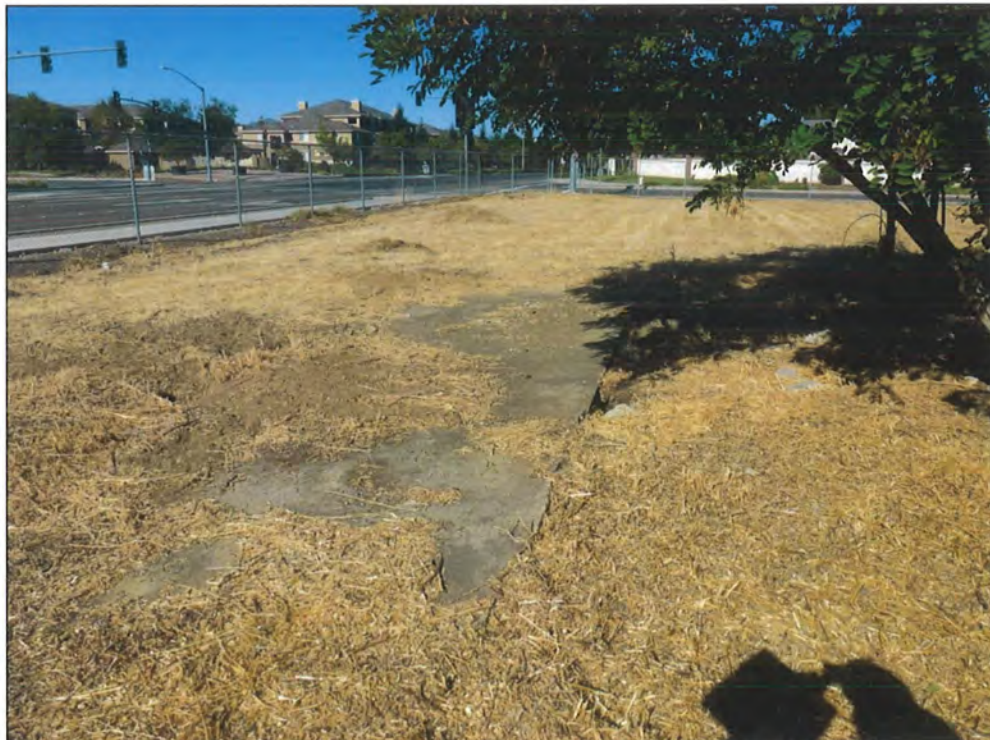
During ECORP's revisit, the site appeared to have been severely altered due to construction activities after the initial recording in 1993. The only remaining features were the U-shaped concrete slab and the possible restroom foundation. None of the raised platforms, walls or steps from Feature 1 could be found. The walls and steps may have been removed or graded, as well as the ramps in the western portion of the site. No indications of a sandbox were observed as the majority of the surface had base rock and granitic rocks imported and graded. Additionally, after review of the site sketch map, it appeared that the eastern end of the site may have been demolished from construction of apartment complexes directly east of the Project Area.

Raised concrete pad overview, view west, 8/23/2013, Photo #011
