ADDENDUM NO. 2
TO
CONTRACT DOCUMENTS
FOR
COUNTRY HILLS DRIVE SOUNDWALL REPLACEMENT
in
ANTIOCH, CALIFORNIA
P.W. 561-3

**to
CONTRACT DOCUMENTS
for
COUNTRY HILLS DRIVE SOUNDWALL REPLACEMENT
in
ANTIOCH, CALIFORNIA
P.W. 561-3**

**GEOTECHNICAL INVESTIGATION
NEW SOUNDWALL
COUNTRY HILLS DRIVE
ANTIOCH, CALIFORNIA**

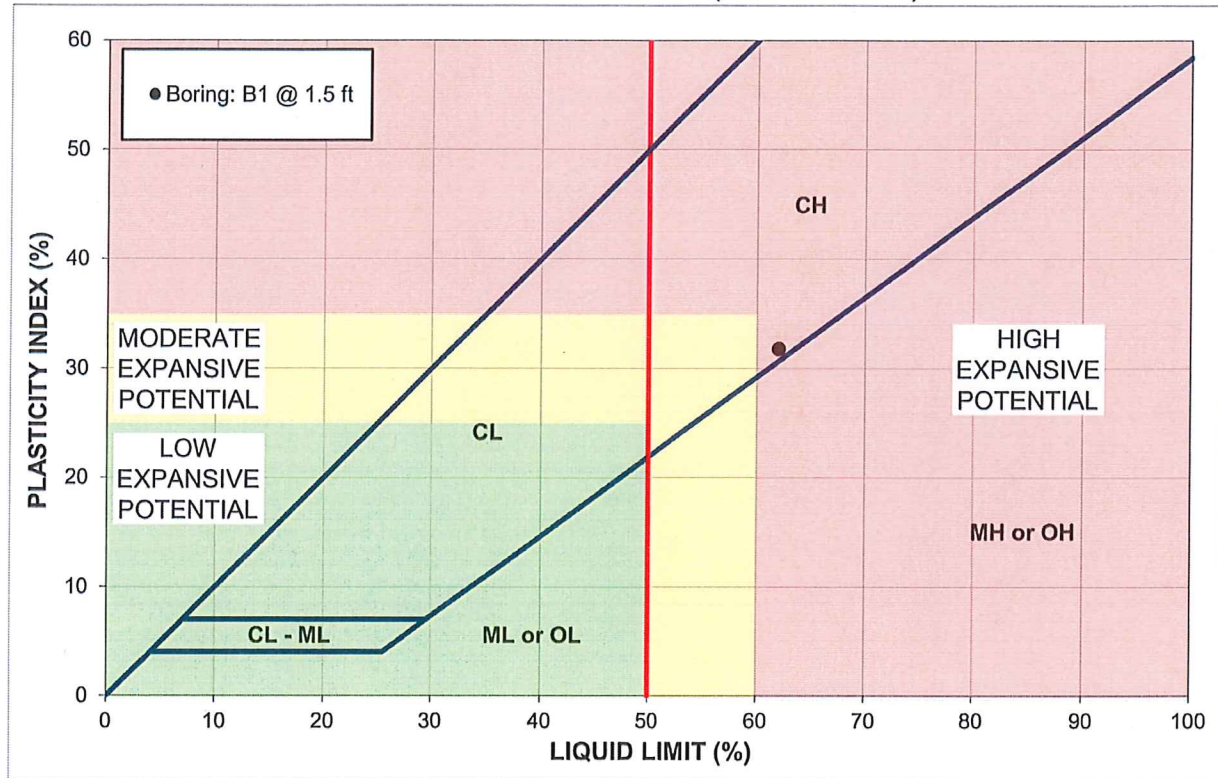
ATTERBERG LIMITS TEST (ASTM D 4318)

Sample	Classification	Liquid Limit (%)	Plastic Limit (%)	Plasticity Index (%)
Boring: B1 @ 1.5 ft	CLAY with Gravel (CH) dark brown mottled tan	62	30	32

PI = 0-3: Non-Plastic
 PI = 3-15: Slightly Plastic
 PI = 15-30: Medium Plasticity
 PI = >30: High Plasticity

Laboratory testing of select soil samples included determination of moisture content, dry density, unconfined compressive strength, and Plasticity Index in general accordance with applicable ASTM standards. The results of the moisture content, dry density, unconfined compressive strength, and Plasticity Index tests are presented on the Boring Logs, Figures A-2 through A-4. Additionally, the results of our Plasticity Index test are presented on Figure A-5. The subsurface exploration and laboratory testing program is discussed in further detail in Appendix A.
